The Bourke Family Farm

COMPOST PACK BEDDING COW SHELTERS

Double compost barns with open central feed lane

The Bourke family farm was visited on Monday 16th April 2018 and the Case Study below is a summary of Paul and Shane's interview and observations made at the site visit.

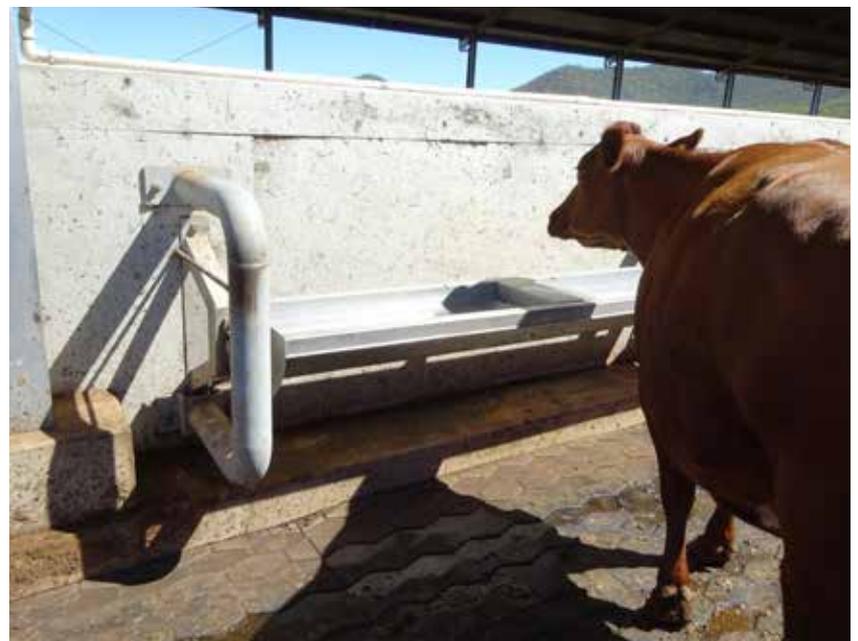
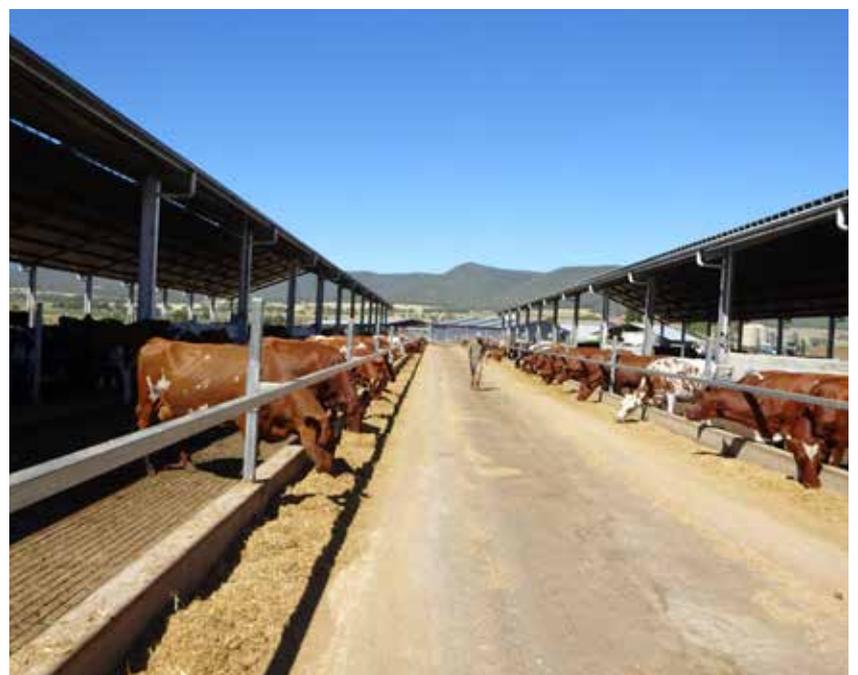
A concrete feed lane and feed alleys were constructed in the middle between the two sheds and watering is by eight easy-wash swing troughs in each feed alley. Both feed alleys are flood washed.

A concrete feed lane and feed alleys were constructed in the middle between the two sheds and watering is by eight easy-wash swing troughs in each feed alley.

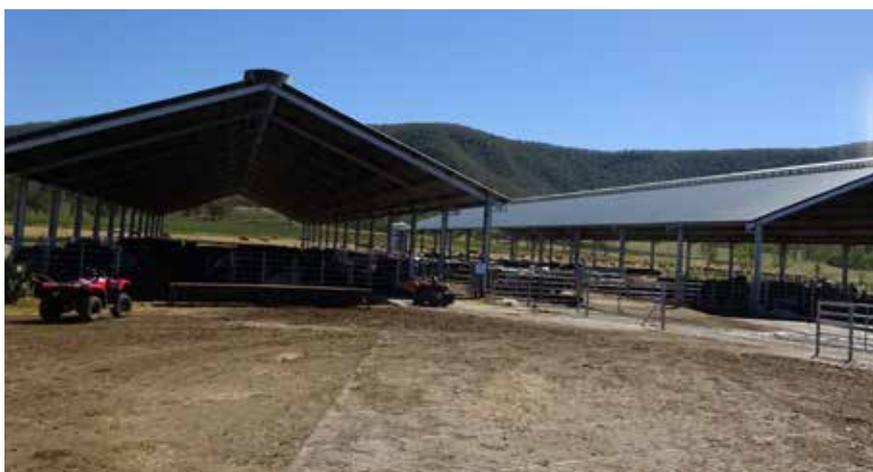
The feed alleys are flood washed twice daily and troughs scrubbed once daily or twice daily when using the shelter day and night.
